**Flood Control Project Maintenance  
Levee Inspections**

## Maintenance Issue Types Only, Levee Inspection Report By Mile - Spring 2018

### Reclamation District No. 0003 Grand Island

Waterway	Bank	Unit Miles	Inspection Start/End	Inspector
Unit No. 01 Left Bank Steamboat Slough	Left	10.95	04/03/2018 04/03/2018	Keith Millard

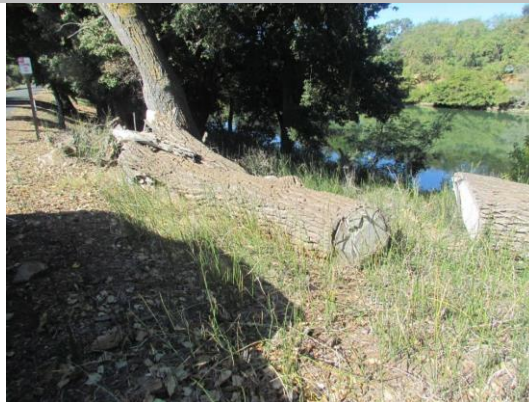
Photo 2 of 4 : SP\_2018\_RD0003\_24\_19\_20180305\_00022.jpg

LM Start	0.13	Rating **	M	Issue No.	19
LM End	0.13	Issue Type +	Ma	Location *	WS
Category	Earthen Levee			GPS Latitude/Longitude	
				Start	End
Item	Encroachments			38.303305 °	38.303305 °
				-121.576537 °	-121.576537 °
DWR ID	DWR_RD0003_01_f_2012_19				
Comment Code					
TR : Tree or limb					
Inspector Comment					
Tree branches and limbs on waterward shoulder.

Looking west at tree branch on waterward shoulder and slope. (Fall 2016)

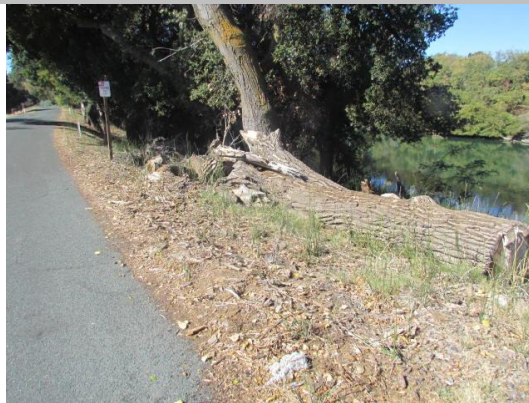
Photo 3 of 4 : SP\_2018\_RD0003\_24\_19\_20180305\_00023.jpg

Looking west at tree branch on waterward shoulder and slope. (Fall 2014)

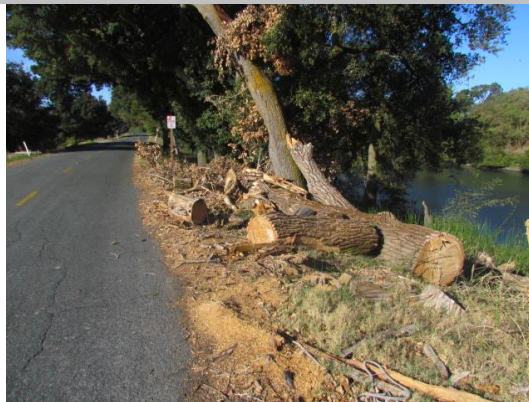
Photo 4 of 4 : SP\_2018\_RD0003\_24\_19\_20180305\_00024.jpg

Looking west at tree branches on waterward shoulder. (Spring 2014)

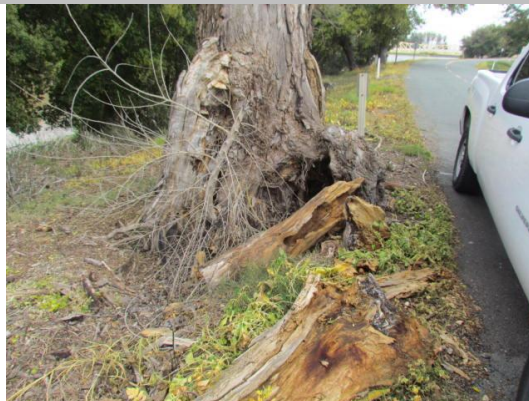
Photo 1 of 3 : SP\_2018\_RD0003\_24\_2\_20180305\_00003.jpg

LM Start	0.13	Rating **	M	Issue No.	2
LM End	0.13	Issue Type +	Ma	Location *	WS
Category	Earthen Levee			GPS Latitude/Longitude	
				Start	End
Item	Erosion / Bank Caving			38.303303 °	38.303303 °
				-121.576538 °	-121.576538 °
DWR ID	DWR_RD0003_01_f_2013_2				
Comment Code					
E2 : Schedule repair of erosion site prior to the next inspection.					
Inspector Comment					
Hole (8ft x 2.5ft x 5ft) next to a large tree on waterward shoulder.

Looking east at hole at the base of an oak tree on the waterward shoulder. (2016)

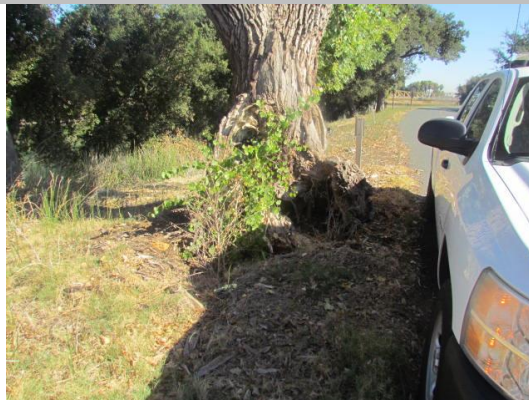
Photo 3 of 3 : SP\_2018\_RD0003\_24\_2\_20180305\_00005.jpg

Looking east at hole at base of tree on waterward shoulder. (2014)

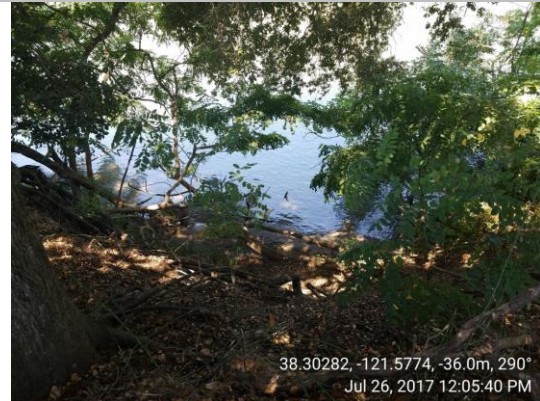
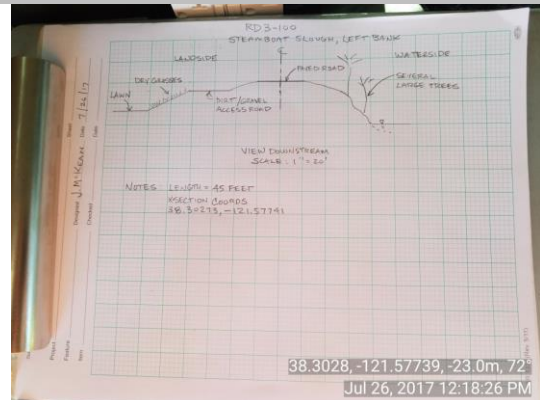
LM Start	0.18	Rating **	A/W	Issue No.	52 (cont)	
LM End	0.21	Issue Type +	Ma	Location *		
Category	Supplemental			GPS Latitude/Longitude		
				Start	End	
Item	2017 Storm Damage			38.302981 °	38.302778 °	
				-121.577336 °	-121.577683 °	
DWR ID	DWR_RD0003_01_s_2018_52					
Comment Code						
Inspector Comment						
Levee Evaluation Comments						
Description: District station 9+63 to 10+85, Sec. 07, T. 5 N. R. 4 E., M.D.M. An erosion site exists along approximately 122 linear feet of the water side slope of Steamboat Slough (Unit 1). Erosion commences approximately 1/3 of the way down the slope from the crown to the waterside toe. Erosion is undercutting existing trees.						
Site ID No: 274						
Site Designation: LMA-100						
Repair Type: Erosion						
Rating: Serious						
Field Date: 7/26/2017						
Notes: trees undercut by erosion

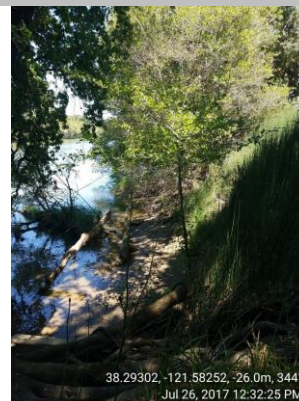
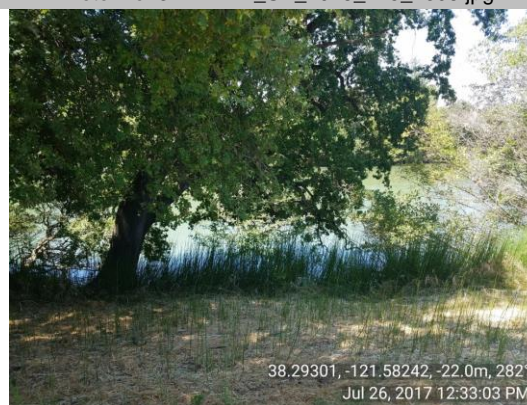
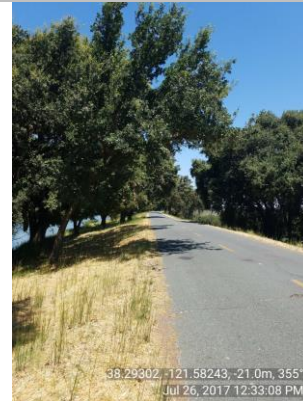
LM Start	0.91	Rating **	A/W	Issue No.	53
LM End	0.97	Issue Type +	Ma	Location *	
Category	Supplemental			GPS Latitude/Longitude	
				Start	End
Item	2017 Storm Damage			38.293381 °	38.292617 °
				-121.582450 °	-121.582675 °
DWR ID	DWR_RD0003_01_s_2018_53				
Comment Code					
Inspector Comment					
Levee Evaluation Comments					
Description:District station 48+20 to 51+06, Sec. 07, T. 5 N. R. 4 E., M.D.M. An erosion site exists along approximately 286 linear feet of the water side slope of Steamboat Slough (Unit 1). The erosion begins approximately 1/2 ofthe way down the slope from the crown to the waterside toe. Erosion is undercutting existing trees.					
Site ID No:275					
Site Designation:LMA-101					
Repair Type: Erosion					
Rating:Serious					
Field Date:7/26/2017					
Notes:

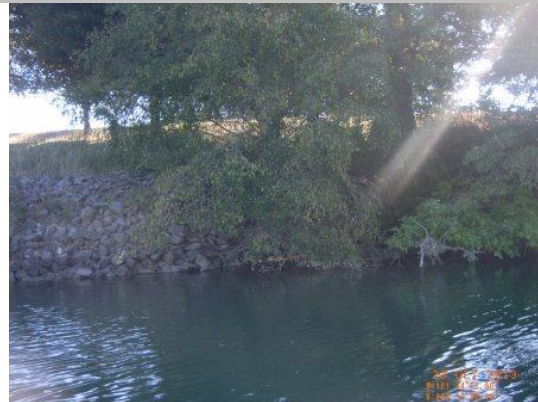
Photo 1 of 1 : SP\_2018\_RD0003\_24\_4\_20180305\_00006.jpg

Comment Code					
Inspector Comment					
1997 - Erosion of sandy levee on top left bank. Site is downstream of a rock section. Large riparian trees on the bank. 1999 - Upstream half of the reach repaired with rock, except for a 30 ft reach at the upstream end. 2001 - Rock repair on the upstream and downstream ends; no revetment at the trees. 2002 - Rock repair is starting to slide off the geotextile at the upstream end. 2005 - One new small tree has fallen. 2006 - 50 ft pocket at the downstream end and at the upstream end with new rock in between. 2007 - Upstream end has been repaired. 2010 - Some minor new erosion. 2011 - Minor new erosion. 2012 - Minor new erosion at the toe. 2015: Significant new erosion, large oak tree on verge of popping out. [2015 Site ID: STM 25-0 L]

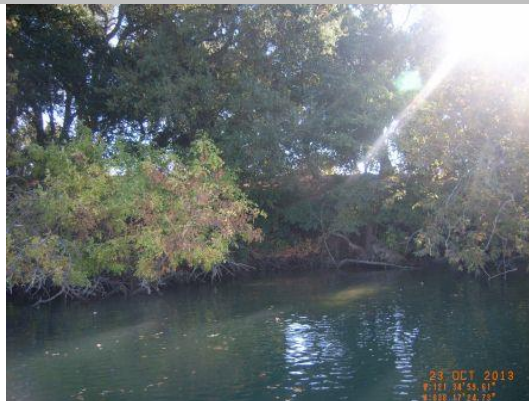
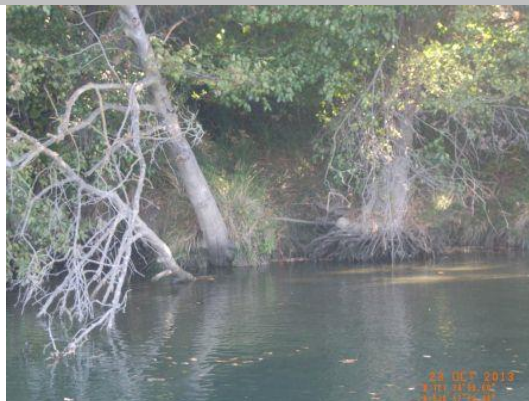
LM Start	1.03	Rating **	M	Issue No.	1
LM End	1.18	Issue Type +	Ma	Location *	WS
Category	Supplemental			GPS Latitude/Longitude	
				Start	End
Item	2015 USACE Erosion Survey, DRAFT			38.291695 °	38.289575 °
				-121.582993 °	-121.583092 °
DWR ID	DWR_RD0003_01_s_2016_1				
Comment Code					
Inspector Comment					
2008 - Area closed sign on bank. Newly fallen trees at both ends and pop outs along the bank. 2010 - Site extended downstream. 2011 - New erosion at the toe. More trees popouts. 2013 - Short vertical sections observed at the downstream end. 2015: New erosion at toe. [2015 Site ID: STM_24-8_L]

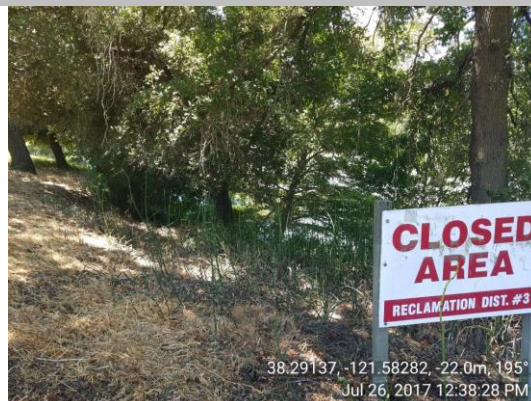
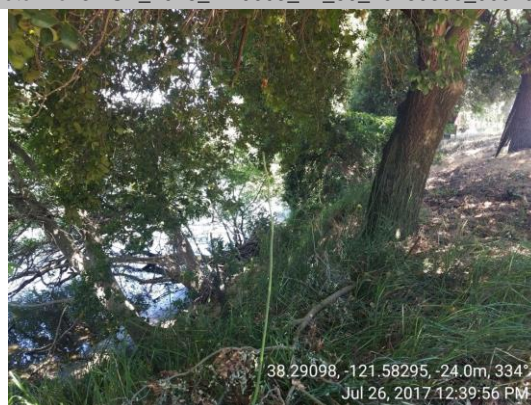
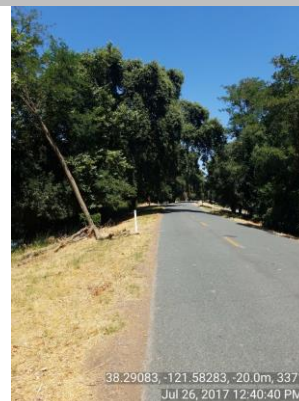
LM Start	1.09	Rating **	A/W	Issue No.	60
LM End	1.10	Issue Type +	Ma	Location *	
Category	Supplemental			GPS Latitude/Longitude	
				Start	End
Item	2017 Storm Damage			38.290819 °	38.290706 °
				-121.582942 °	-121.582939 °
DWR ID	DWR_RD0003_01_f _ 2017_60				
Comment Code					
Inspector Comment					
Levee Evaluation Comments					
Description:District station 57+57 to 57+98, Sec. 18, 1. 5 N. R. 4 E., M.D.M. An erosion site exists along approximately 41 linear feet of the water side slope of Steamboat Slough (Unit 1). The erosion commences approximately 1/2 ofthe way down the slope from the crown to the waterside toe.					
Site ID No:276					
Site Designation:LMA-102					
Repair Type: Erosion					
Rating:Area of Concern					
Field Date:7/26/2017					
Notes:

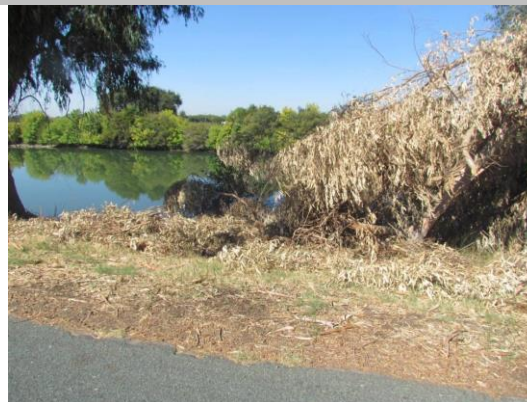
Photo 1 of 2 : SP\_2018\_RD0003\_24\_62\_20180305\_00051.jpg

LM Start	1.69	Rating **	U	Issue No.	62
LM End	1.69	Issue Type +	Ma	Location *	WS
Category	Earthen Levee			GPS Latitude/Longitude	
				Start	End
Item	Encroachments			38.283747 °	38.283747 °
				-121.587622 °	-121.587622 °
DWR ID	DWR_RD0003_01_f_2016_62				
Comment Code					
TR : Tree or limb					
Inspector Comment					
Broken tree branch on waterward slope.

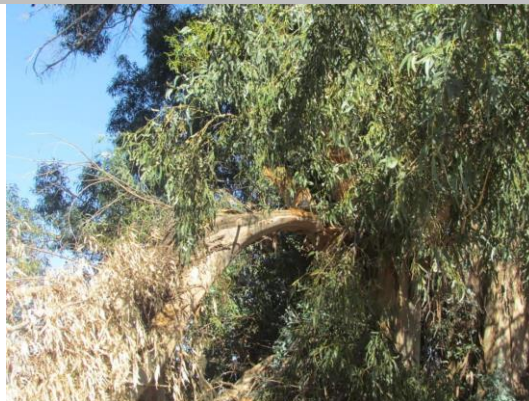
Photo 2 of 2 : SP\_2018\_RD0003\_24\_62\_20180305\_00052.jpg

LM Start	1.69	Rating **	U	Issue No.	62 (cont)	
LM End	1.69	Issue Type +	Ma	Location *	WS	
Category	Earthen Levee			GPS Latitude/Longitude		
				Start		End
Item	Encroachments			38.283747 °	38.283747 °	
				-121.587622 °	-121.587622 °	
DWR ID	DWR_RD0003_01_f_2016_62					
Comment Code						
TR : Tree or limb						
Inspector Comment						
Broken tree branch on waterward slope.

Looking southwest at broken branches on waterward slope.

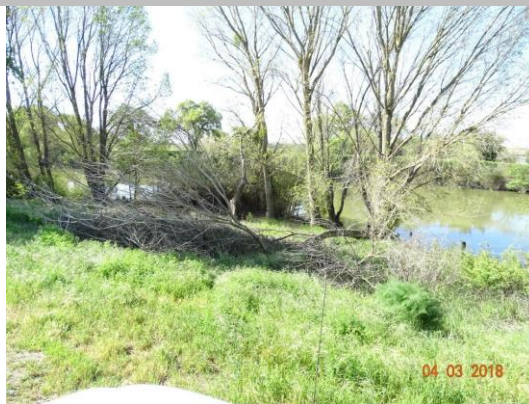
Photo 1 of 1 : SP\_2018\_RD0003\_24\_55\_20180403\_00171.jpg

Fallen tree limb on waterside.

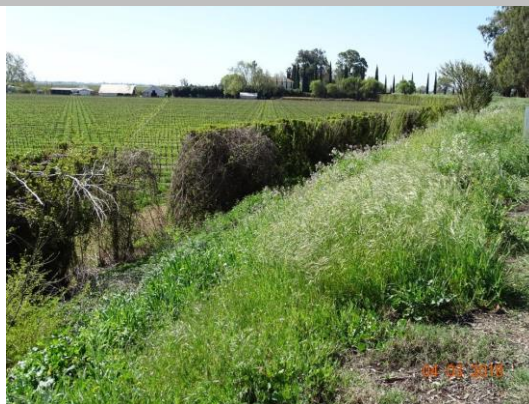
Photo 1 of 1 : SP\_2018\_RD0003\_24\_65\_20180403\_00174.jpg

Landside vegetation.

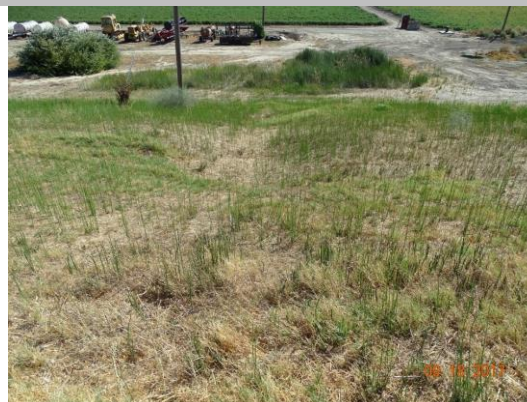
Photo 1 of 1 : SP\_2018\_RD0003\_24\_83\_20180305\_00075.jpg

LM Start	4.87	Rating **	M	Issue No.	83
LM End	4.87	Issue Type +	Ma	Location *	LS
Category	Earthen Levee			GPS Latitude/Longitude	
				Start	End
Item	Slope Stability			38.245903 °	38.245903 °
				-121.600851 °	-121.600851 °
DWR ID	DWR_RD0003_01_f_2017_83				
Comment Code					
S1 : Repair slope instability.					
Inspector Comment					
Landside slope has a depression.

Looking east on landside slope.

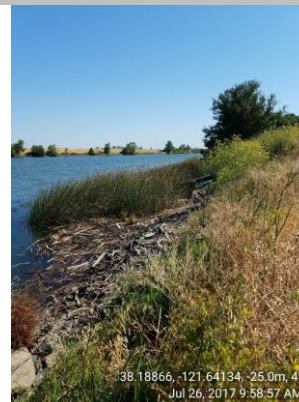
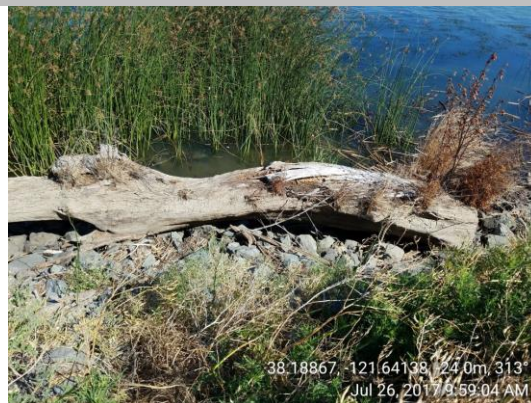
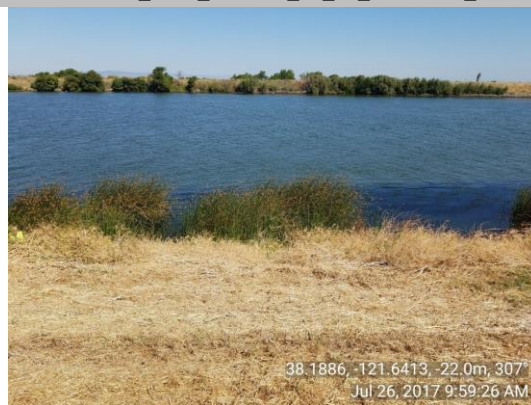
LM Start	<b>10.15</b>	Rating **	A/W	Issue No.	<b>72</b>
LM End	<b>10.21</b>	Issue Type +	Ma	Location *	
Category	Supplemental		GPS Latitude/Longitude		
			Start	End	
Item	2017 Storm Damage		38.188431 °	38.187803 °	
			-121.641703 °	-121.642478 °	
DWR ID	DWR_RD0003_01_f_2017_72				
Comment Code					
Inspector Comment					
<p>Levee Evaluation Comments</p> <p>Description: District station 536+35 to 539+47, Sec. 16, T. 4 N. R. 3 E., M.D.M. The waterside slope experienced sloughing and erosion along approximately 312 linear feet of Steamboat Slough (Unit 1). Sloughing commences at approximately 1/4 of the way down the slope from the crown and extends to the rip rap.</p> <p>Site ID No: 277</p> <p>Site Designation: LMA-103</p> <p>Repair Type: Erosion</p> <p>Rating: Area of Concern</p> <p>Field Date: 7/26/2017</p> <p>Notes:</p>

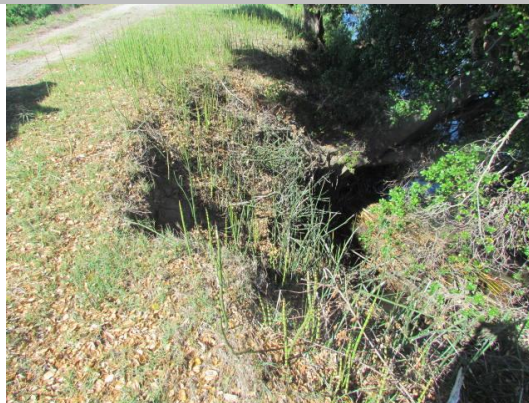
Photo 2 of 2 : SP\_2018\_RD0003\_24\_96\_20180305\_00080.jpg

LM Start	10.75	Rating **	A/W	Issue No.	96 (cont)	
LM End	10.75	Issue Type +	Ma	Location *	WS	
Category	Earthen Levee			GPS Latitude/Longitude		
				Start	End	
Item	Erosion / Bank Caving			38.183422 °	38.183422 °	
				-121.650182 °	-121.650182 °	
DWR ID	DWR_RD0003_01_s_2013_96					
Comment Code						
E2 : Schedule repair of erosion site prior to the next inspection.						
Inspector Comment						
Erosion extends to waterward shoulder.

Looking southwest at erosion on waterward slope.

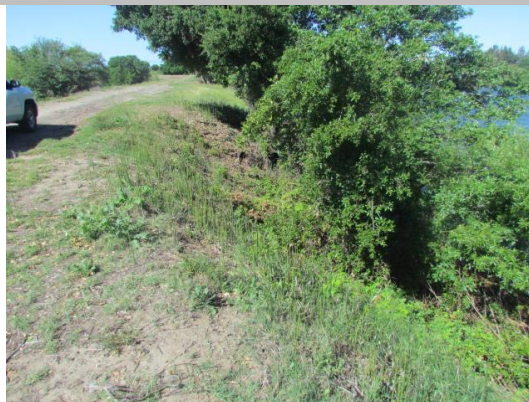
Photo 1 of 2 : SP\_2018\_RD0003\_24\_97\_20180305\_00081.jpg

LM Start	10.78	Rating **	A/W	Issue No.	97
LM End	10.80	Issue Type +	Ma	Location *	WS
Category	Earthen Levee			GPS Latitude/Longitude	
				Start	End
Item	Erosion / Bank Caving			38.183228 °	38.183123 °
				-121.650797 °	-121.651070 °
DWR ID	DWR_RD0003_01_s_2013_97				
Comment Code					
E2 : Schedule repair of erosion site prior to the next inspection.					
Inspector Comment					
Erosion extends to waterward shoulder.

Looking south at erosion on waterward slope.

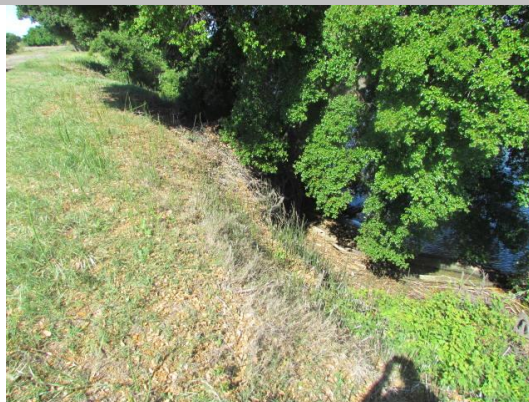
Photo 2 of 2 : SP\_2018\_RD0003\_24\_97\_20180305\_00082.jpg

Looking southwest at erosion on waterward slope.

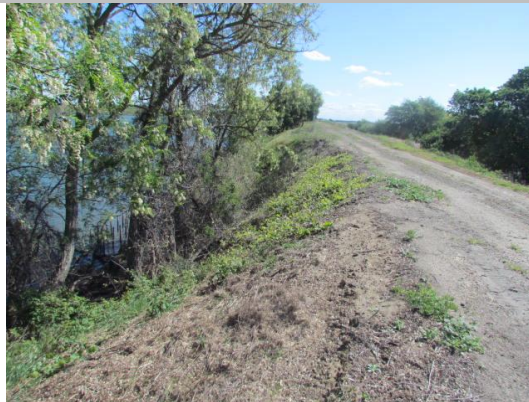
Photo 1 of 3 : SP\_2018\_RD0003\_24\_98\_20180305\_00083.jpg

LM Start	10.86	Rating **	A/W	Issue No.	98
LM End	10.89	Issue Type +	Ma	Location *	WS
Category	Earthen Levee			GPS Latitude/Longitude	
				Start	End
Item	Erosion / Bank Caving			38.182792 °	38.182672 °
				-121.652142 °	-121.652555 °
DWR ID	DWR_RD0003_01_s_2013_98				
Comment Code					
E2 : Schedule repair of erosion site prior to the next inspection.					
Inspector Comment					
Erosion extends to waterward shoulder.

Looking north at erosion on waterward slope.

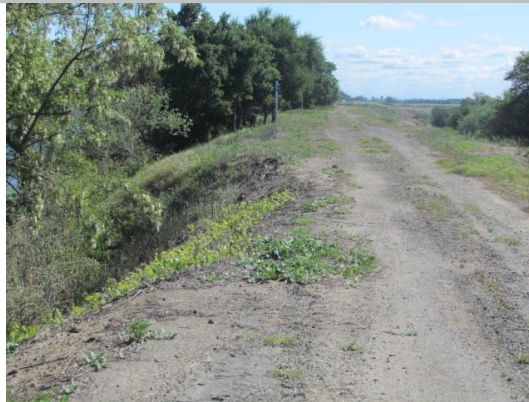
Photo 2 of 3 : SP\_2018\_RD0003\_24\_98\_20180305\_00084.jpg

Looking northwest at erosion on waterward shoulder and slope.

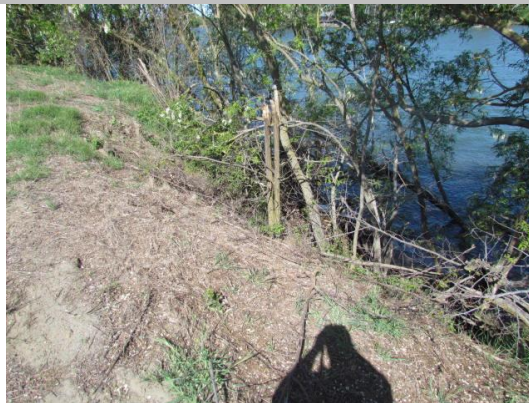
Photo 3 of 3 : SP\_2018\_RD0003\_24\_98\_20180305\_00085.jpg

Looking west at erosion on waterward slope.

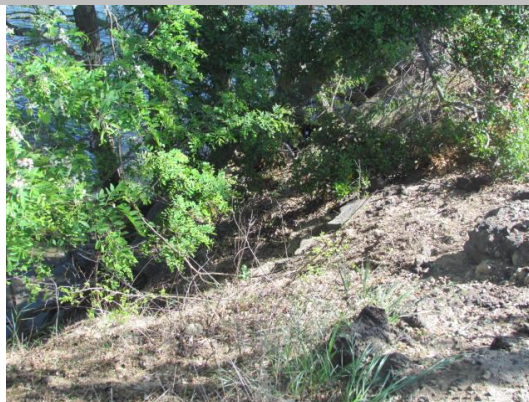
Photo 1 of 2 : SP\_2018\_RD0003\_24\_99\_20180305\_00086.jpg

Looking west at erosion on waterward slope.

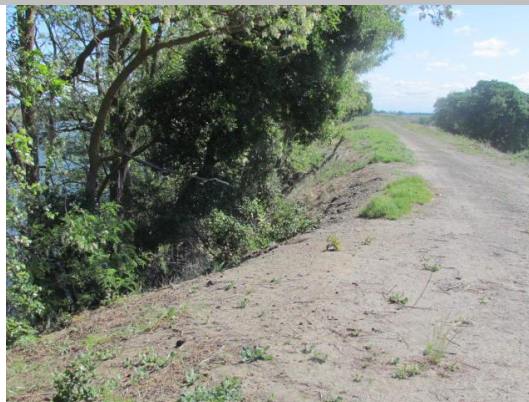
Photo 2 of 2 : SP\_2018\_RD0003\_24\_99\_20180305\_00087.jpg

Looking north at erosion on waterward shoulder and slope.

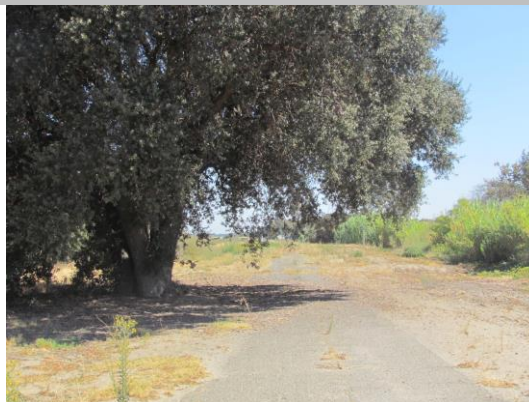
Photo 1 of 1 : SP\_2018\_RD0003\_25\_4\_20180305\_00006.jpg

Looking east at untrimmed tree on landward shoulder.

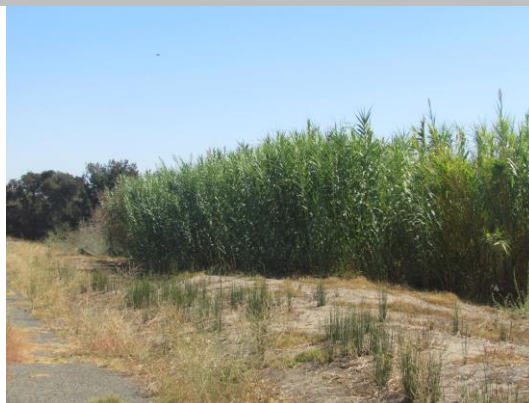
Photo 1 of 2 : SP\_2018\_RD0003\_25\_5\_20180305\_00007.jpg

Looking southeast at bamboo on waterward slope. (Fall 2016)

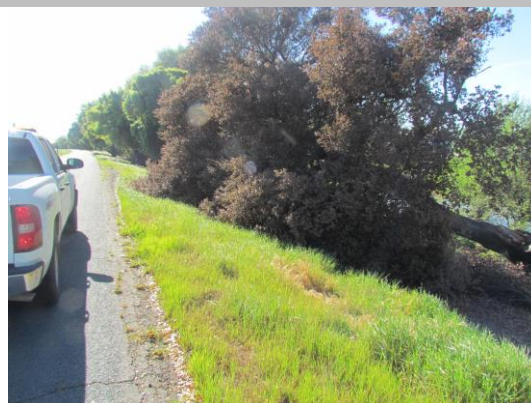
Photo 3 of 3 : SP\_2018\_RD0003\_25\_129\_20180305\_00095.jpg

Looking northeast at fallen tree on waterward slope.

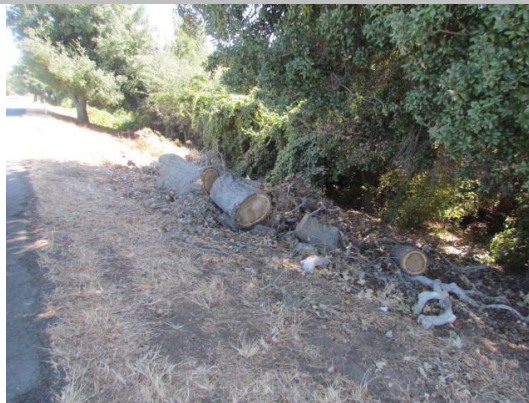
Photo 2 of 2 : SP\_2018\_RD0003\_25\_140\_20180305\_00113.jpg

Looking at tree branches and tree limbs on waterward shoulder and slope.

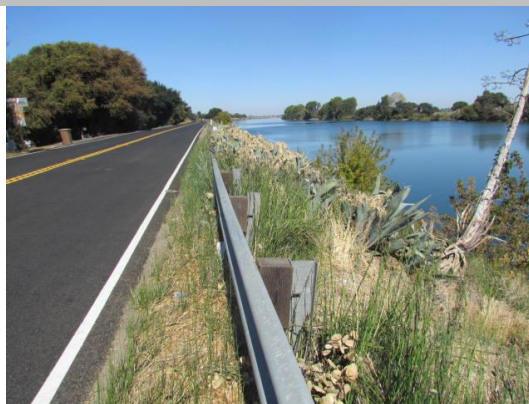
Photo 1 of 1 : SP\_2018\_RD0003\_25\_145\_20180305\_00121.jpg

Looking northeast at century plants on waterward shoulder and slope.

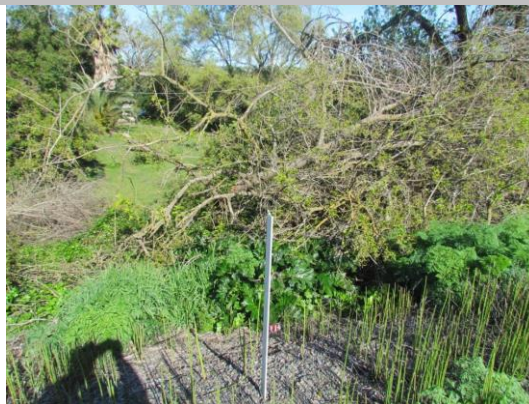
Photo 1 of 1 : SP\_2018\_RD0003\_25\_97\_20180305\_00084.jpg

Looking west at fallen tree on landward slope.

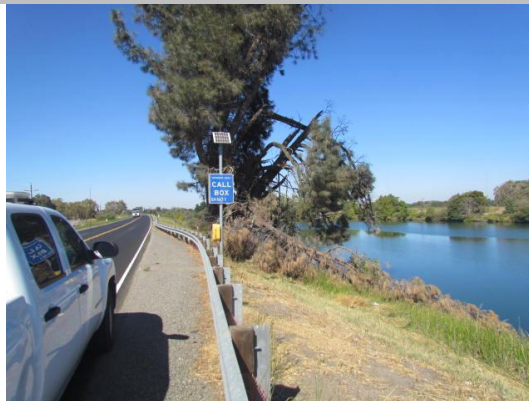
Photo 1 of 2 : SP\_2018\_RD0003\_25\_15\_20180305\_00023.jpg

Looking northeast at broken and cracked tree branches on waterward slope.

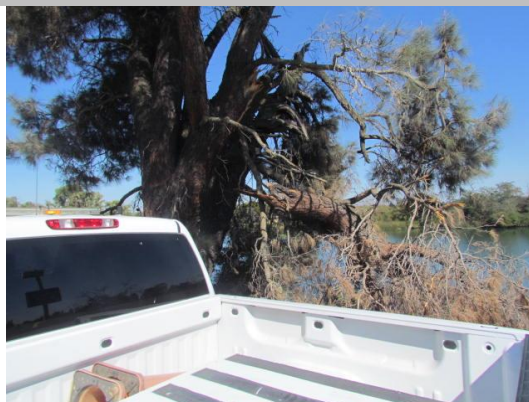
Photo 2 of 2 : SP\_2018\_RD0003\_25\_15\_20180305\_00024.jpg

Looking east at broken and cracked tree branches on waterward slope.

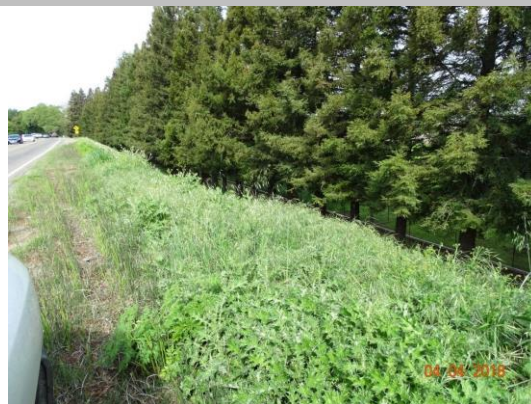
Photo 1 of 1 : SP\_2018\_RD0003\_25\_183\_20180404\_00293.jpg

Heavy vegetation on landside slope prevents inspection.

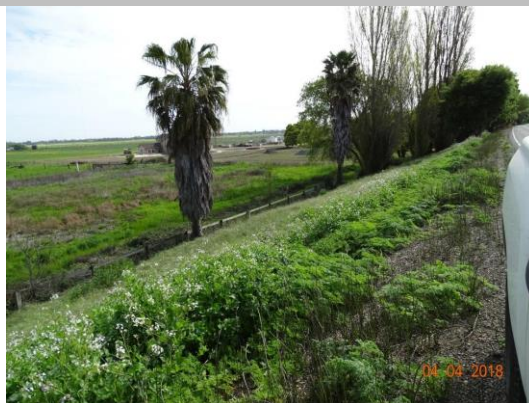
Photo 1 of 1 : SP\_2018\_RD0003\_25\_182\_20180404\_00292.jpg

Heavy vegetation on landside slope prevents inspection.

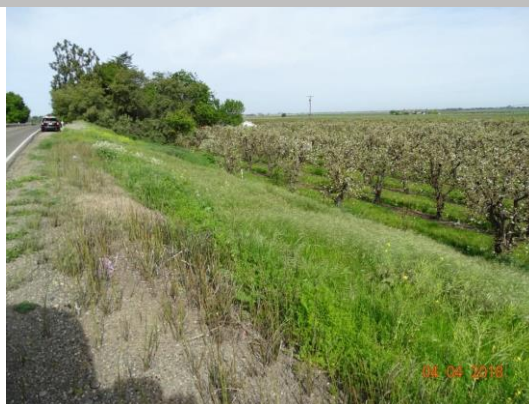
Photo 1 of 1 : SP\_2018\_RD0003\_25\_163\_20180404\_00290.jpg

Tall landside vegetation prevents inspection.

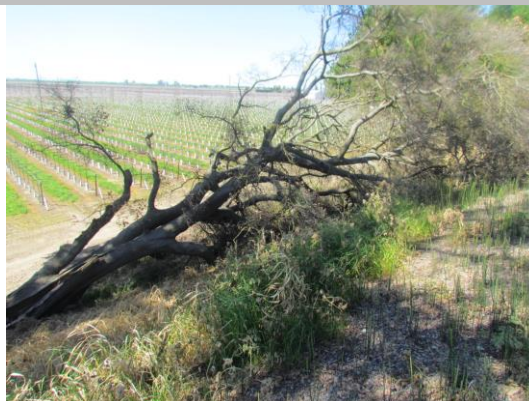
Looking northwest at fallen tree at landward toe.

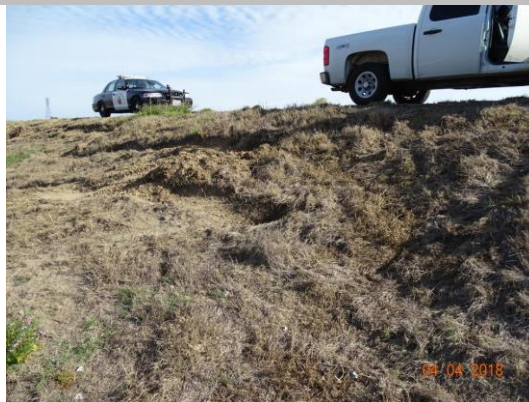
Vehicle erosion on landside slope should be repaired.

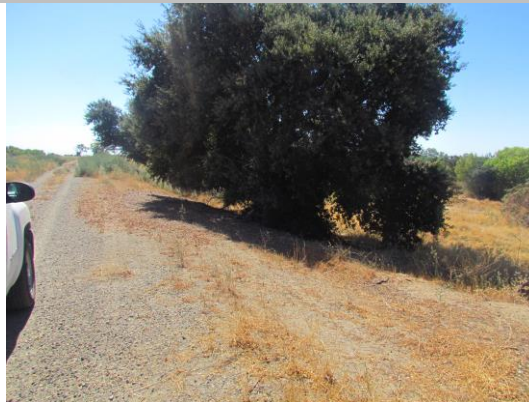
Looking southeast at untrimmed trees on waterward slope and toe.
